26. Survey Name: Colton Historic Resources Survey

HISTORIC RESOURCES INVENTORY

1. Historic Name: None
2. Common or Current Name: None
3. Number & Street: 1088 North 9th Street  
City: COLTON Vicinity Only: Zip:92324 County (3-Letter Designator):SBR
4. Quad Map No.: 1074 UTM A: 11/470520/3770490 B: C: D:
5. Parcel No: 0161-192-08 Other:

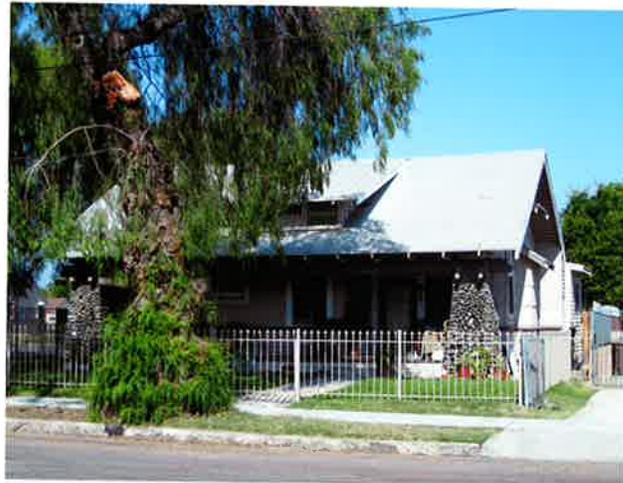
A single story, rectangular shaped structure of wood construction on an east/west orientation in the Craftsman style. Roof is side gable with composite shingles and exposed rafters. An external chimney, consisting of a battered cobble base, then changing to brick work is present. A shed dormer is present, with two verticle slatwork attic vents on either side of a narrow, rectangular opening. Shed roofs extend out over attic vents that are located within the gable ends. Siding is long narrow shingles, arranged in a vertical pattern. A belt rail extends below the windowline and clapboard is installed below this. Windows consist of both double hung and casement-with-transom. An integral full length veranda extends along the front of the building. The veranda roof is supported by two massive battered cobble piers located on either corner. A single, concrete step extends away from the veranda. A small, enclosed bay is present on the south wall. It appears that the windows in this bay were covered over. No foundation is present. It appears that an additional was added to the rear of the building. A large tree dominates the front yard, with vinework covering one pier.

\*windows not currently covered over

Original leaded glass exists in front room (individual designs)

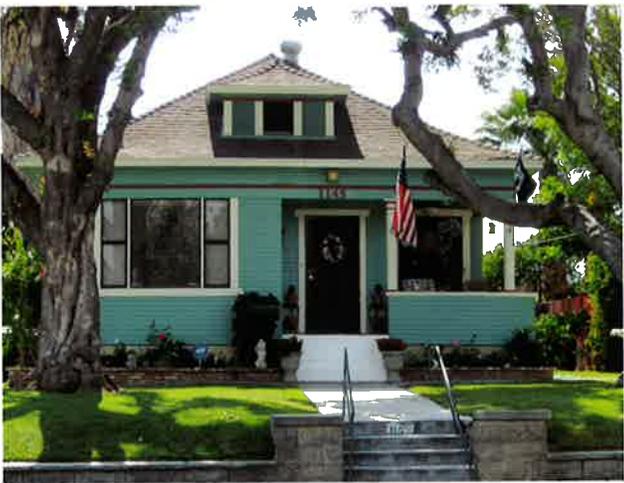
A single story, rectangular shaped building of wood construction on an east/west orientation in the Neoclassical style. Roof is bellcast hip with composite shingles. A hipped dormer is centrally located, with a screened opening surrounded on either side by slatwork vents. Eaves are boxed. Siding is narrow clapboard. Windows appear to be aluminum frames, however the sash configuration is similar to the original windows. An integral porch is located along one side of the front of the building. Porch roof is supported by a classical column mounted on a solid balustrade. Foundation is cast stone. Cast concrete steps extend out from the porch, with cast stone side rails. An addition has been made to the rear of this building, of stucco construction. Mature trees surround the property.

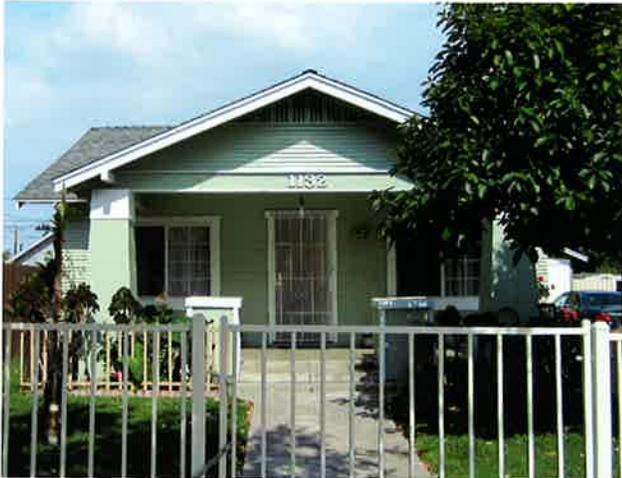
A single story, rectangular shaped building of wood construction on an east/west orientation in the Craftsman style. The facade is symmetrical. Roof is side gable with composite shingles. A lower front gable extends out over the front porch. Siding is shiplap. Two fixed sash with five-lite transom windows are located on either side of the central front door. Two large battered plaster columns support the roof, with two smaller pedestals located on either side of the front steps. Foundation appears to be concrete. A small addition is located on the south side, consisting of a screened in entrance covered by a shed roof. A separate front gable garage is located to the rear of the building. A concrete driveway with grass centerstrip extends past the house. No landscaping is present.

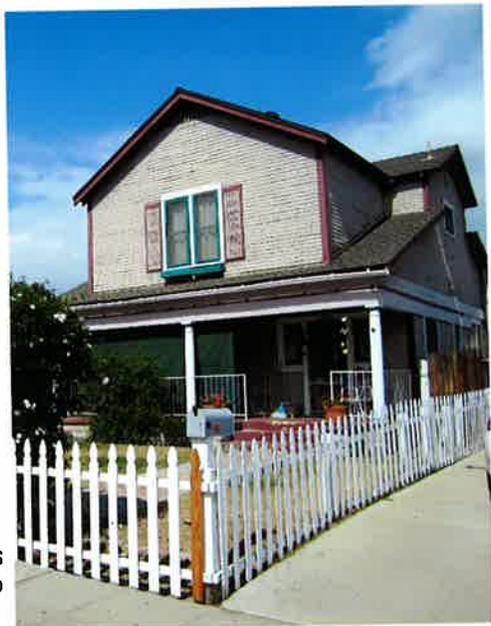
A two story, rectangular shaped structure of wood construction on an east/west orientation with Craftsman details. Roof consists of a central side monitor with gable cover, with two shed roof extensions coming forward and to the rear covered in composition shingles. A lower front gable extends forward. Siding is shiplap. Windows are double hung. An integral veranda extends along the front of the building. Veranda supports are classical columns. A wrought iron railing has been added between the columns. Front door has two small single windows with four over one fixed sashes located on either side. Front door is wood and glass panel. Foundation is rough block. A white picket fence extends around the front yard, and some mature landscaping is present.

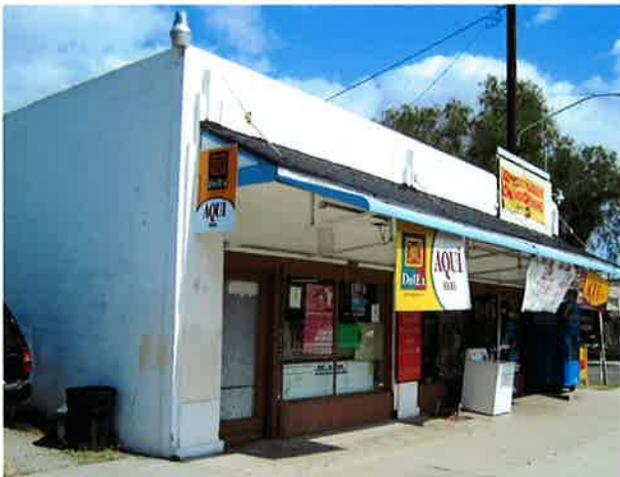
A single story, rectangular shaped building of concrete construction with Art Deco details. Roof is flat. A shed roof, attached to the main building with guy wires extends across the front of the building. Roofing on this extension is composite shingles. An aluminum awning has been added along the entire face of the shed roof. Two store fronts exist along the property, although the interior has been merged as one. Both fronts consist of large aluminum and glass fixed sashes. The doorway in the larger opening is aluminum and glass, while the door in the smaller store appears to be wood frame that has been boarded over. A concrete sill runs below each window. One store front consists of a door opening and single window, while the second store front consists of two windows with a central front door. Transoms are located over the windows, but these have been painted or otherwise covered over. Some art-deco styling is found along the cast centerposts separating the two store fronts and at the corners. Wrought iron security fencing has been installed over the windows and doors.

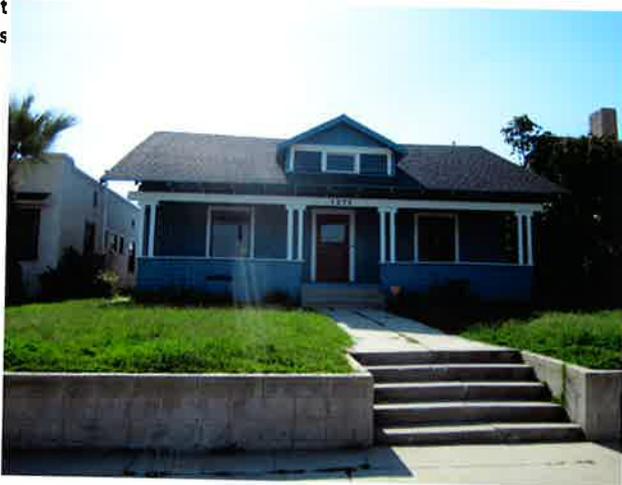
A single story, rectangular shaped building of wood construction on an east/west orientation in the Craftsman style. Roof is side gable with composite shingles. A front gable dormer is centrally located on the roof. The siding in the dormer consists of board and batten. Three openings are present in the dormer. One is a two light single sash window with slatwork attic vents located on either side. Siding in the gable ends consists of board and batten above the window line and shiplap to below the windows and clapboard to the foundation. Windows on the side appear to be double hung. The facade of the building is symmetrical. Two windows, consisting of a fixed sash and leaded diamond transom are located on either side of the front door. Two small bay windows project out on either side of building. These bays do not extend below the window line and have shed type roofs. A full width integral front porch is present. The roof is supported by four paired columns with decorative wood capitals, resting on a solid wood balustrade. Cast concrete steps extend out from the front of the building. An addition to the rear of the building appears to have been added on at a later date. Simple landscaping is present.

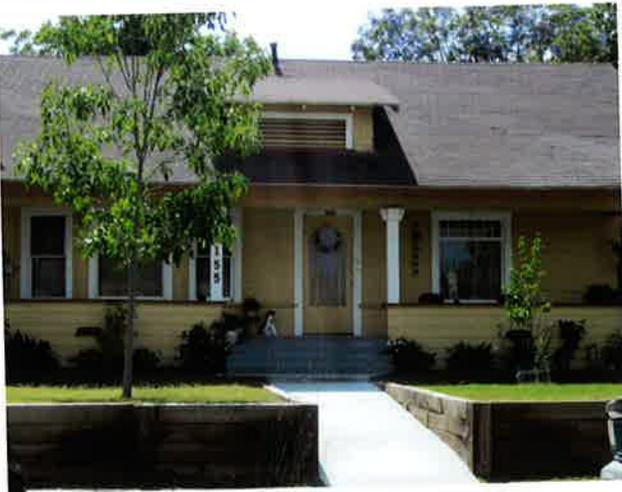
A single story, rectangular shaped building of wood construction on an east/west orientation in the Craftsman style. Roof is side gable with composite shingles. A shed dormer is centrally located, with a slatwork attic vent and shingle siding. Siding is wood shiplap above window sill line and clapboard below. Windows are double hung. A small bay window juts out into the integrated full length veranda. The windows in the angles are double hung, while the parallel window is fixed sash with 14-lite transom. A second fixed sash with 14-lite transom window is located on the other side of the central front door. Front door is wood with full length, narrow rectangles of glass. The veranda roof is supported by square wood columns resting on a solid wood balustrade, sheathed in clapboard. Cast concrete steps extend out from the veranda. A second small bay window is located on the south wall. Foundation appears to be cast concrete. Some landscaping is present, and two prominent palms are located in front of the building.

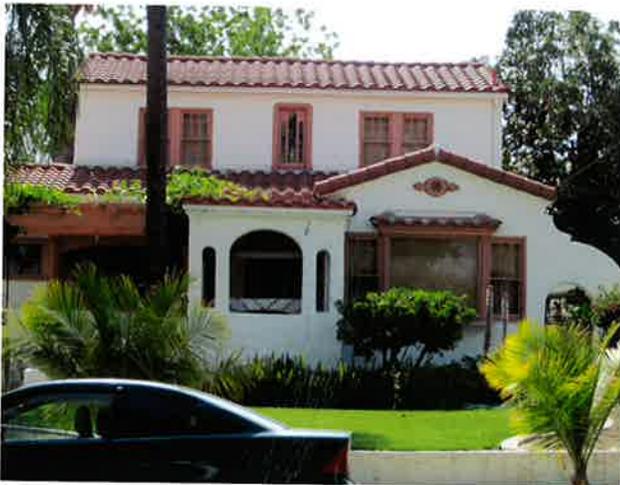
A two story, irregularly shaped building of wood and stucco construction on an east/west orientation in the Spanish Revival style. The main mass of the building has a side gable roof, while a single story wing extends forward in a front gable. A second single story side gable wing projects to the south. Roof is covered in composite shingles. Siding is rough textured plaster. An external chimney, with arched chimney pot is located on the south wall of the single story side gable. Windows appear to be pairs of six-over-one double hung. A large arched single sash window is predominant in the side gable wing, surrounded on either side by smaller, single sash rectangular windows. A large fixed sash window is also located in the front gable, with two smaller double hung windows located on either side. Decorative molding in a twisted rope pattern separates the two smaller windows from the main window. A cast plaster detailed attic vent is located in the front gable end. A small awning extends over the front window. A small, semi-enclosed alcove covers the front entrance. This alcove has a large, arched opening with two smaller arched openings on either side. These openings extend to the height of the window sills. An open patio, covered with a latticework cover and a solid half-wall is located at the junction of the entry alcove, the second story mass and the side gable wing. Concrete steps extend around the wall to the side driveway. A low, stucco arched side rail extends down the steps. A concrete driveway with grass center strip extends past the south side of the building. Landscaping is mature and is dominated by two towering palm trees, in front and a single palm tree to the rear.

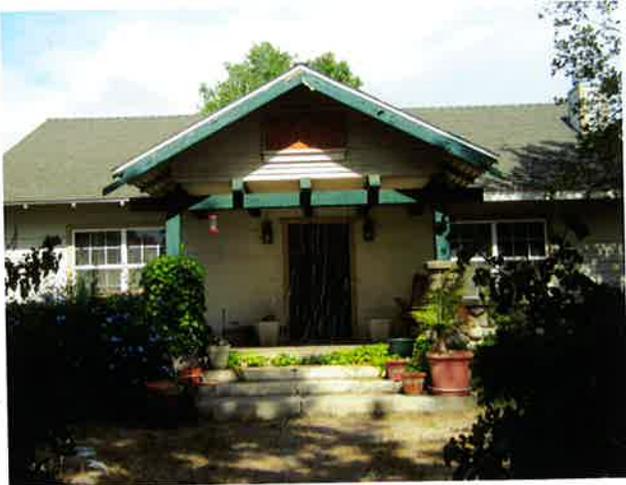
A single story, irregular shaped building of wood construction on an east/west orientation in the Craftsman style. Facade is symmetrical. Roof is side gable, with lower side gable to the rear and lower front gable. Shingles are composite. Multiple lite attic vents are present in the gable ends. An external stone chimney is located on the south side. Siding is wood clapboard. Two small bays windows are present on both sides of the building. Side windows are casement, opening inward. Two windows are located on either side of the central front door. These consist of a fixed sash with transom. A wide concrete patio extends across the full facade of the building. Large open beams extend out from the house, mimicking those found under the front gable that covers the front door. These beams extend out to a cross beam that is supported by four wood square posts resting on battered cobblestone piers. A solid cobblestone balustrade is also present. This arrangement also extends out to the northside of the house in an open beam porte cochere. Expansive concrete steps extend out from the front of the house to the entry walk, while a second set extends from the patio to the driveway. A separate garage is located to the rear of the building and is joined to the street by a concrete driveway that extends along the north side of the building. Landscaping is mature.

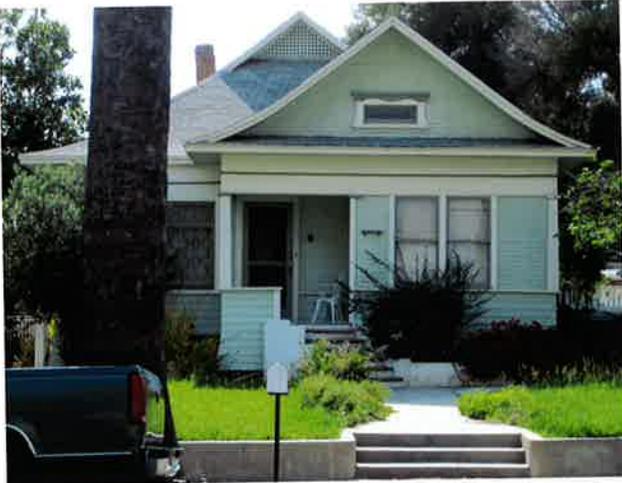
A single story, rectangular shaped building of wood construction on an east/west orientation in the Neoclassical style. Roof is hipped gable bellcast with composite shingles. A small internal chimney is located on the rear. Eaves are boxed. Siding is clapboard. Windows appear to be double hung. A separate front porch extension is present. This extension has a bellcast gable roof. A small queen-anne style fixed sash window with decorative lintel and sill is present in the gable end. Half of the porch has been converted to interior space. This conversion appears to have occurred after 1928, since it does not appear on the Sanborn Map. The porch roof is supported by a square column resting on a solid wood balustrade that is sheathed in clapboard. A small bay window is located on the facade. All front windows are covered in aluminum awnings that obscure the windows. Brick steps come off the front porch at an angle to the facade. These appear to have been added at a later date. Landscaping is mature, and the front yard is dominated by a large tree and several large bushes.
